MERRIMACK RIVER BASIN  
WESTFORD, MASSACHUSETTS

MURRAY PRINTING COMPANY DAM  
MA 00130

PHASE I INSPECTION REPORT  
NATIONAL DAM INSPECTION PROGRAM

APRIL, 1979

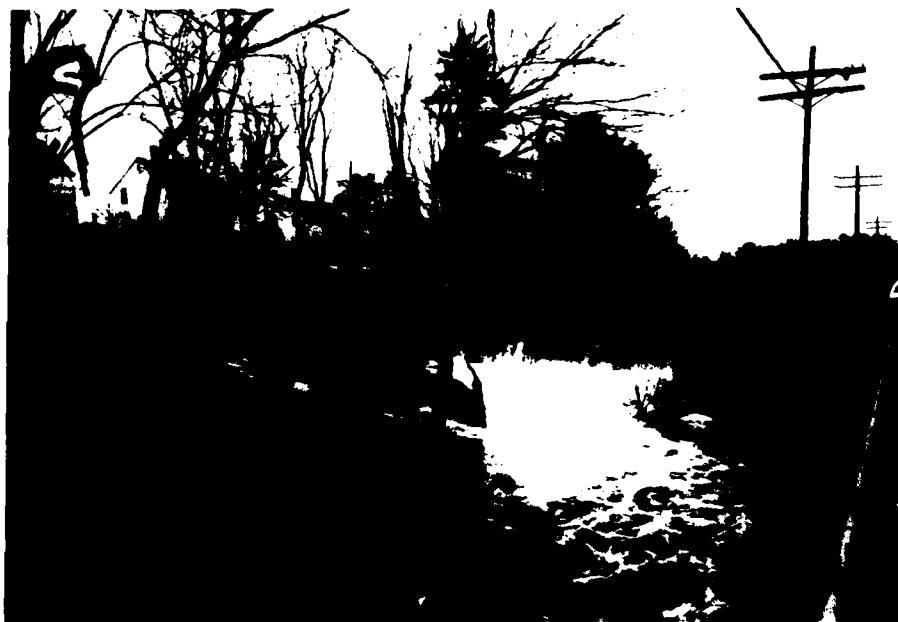
1. Overview of Murray Printing Company Dam

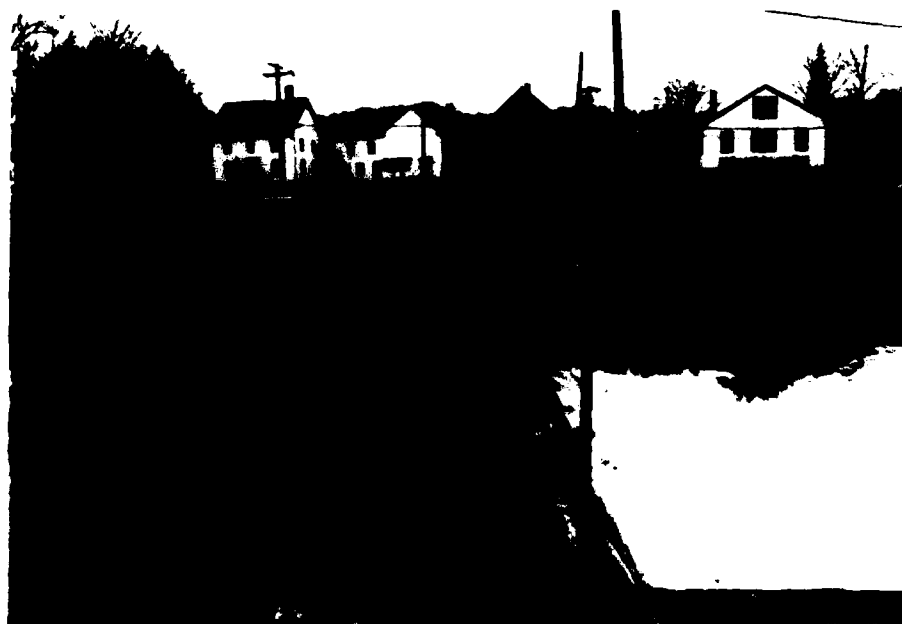
4. The walkway over the main spillway, Photo No. 5, is in excellent condition. Note that the walkway boards over the flashboards are hinged for access below to manually remove the flashboards.
5. The earth abutments on either side of the dam, Photos No. 4, 5 and 6, have stone block protection on the upstream side and are covered by weeds and brush. Minor depressions were noted at the right abutment. The ground is several inches lower than the adjacent concrete at the left abutment, Photo No. 4.

5. Left abutment of dam and walkway over main spillway

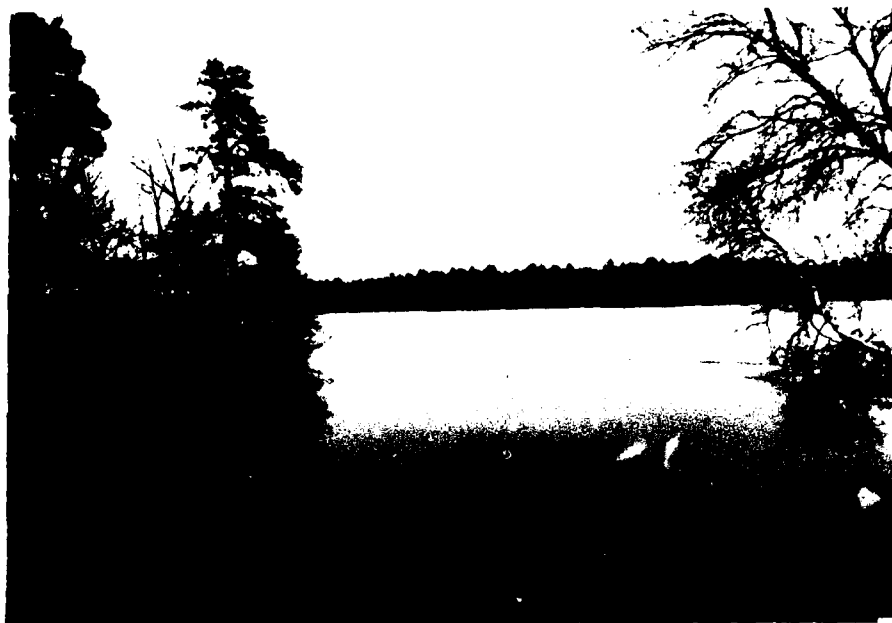
11. Forge Pond reservoir at entrance to dam approach channel
